SERVICE NO. 1251

BULLETIN

Date: April 10, 2013 (S)

STABILATOR TRIM BARREL INSPECTION

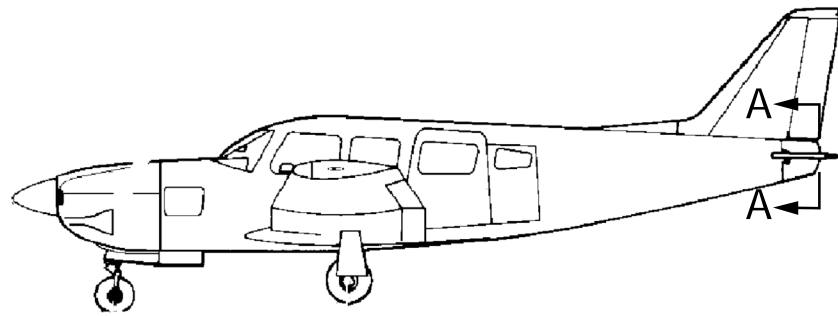
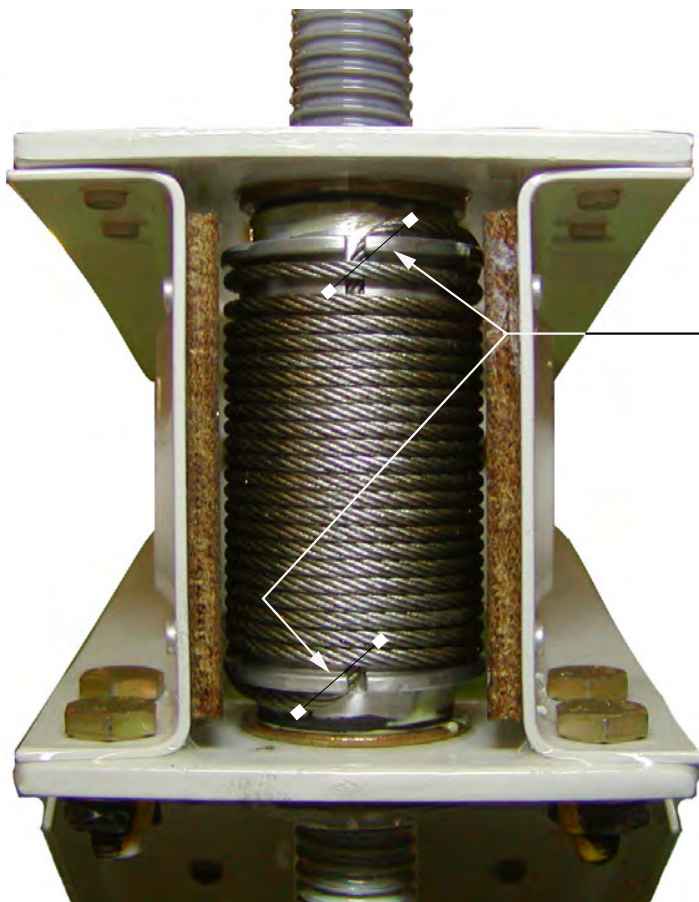
Figure 1

- Identify the stabilator trim barrel and examine the routing of the stabilator trim cable at the locations shown in Figure 1. Additionally, compare the installed trim barrel against the CORRECT and INCORRECT trim barrel details shown in Figure 2.

Dashed lines identify correct geometry of diagonally machined grooves in the stabilator trim barrel flanges.

VIEW A-A
CORRECT

Rear view of correct stabilizer trim barrel, with cable properly routed.

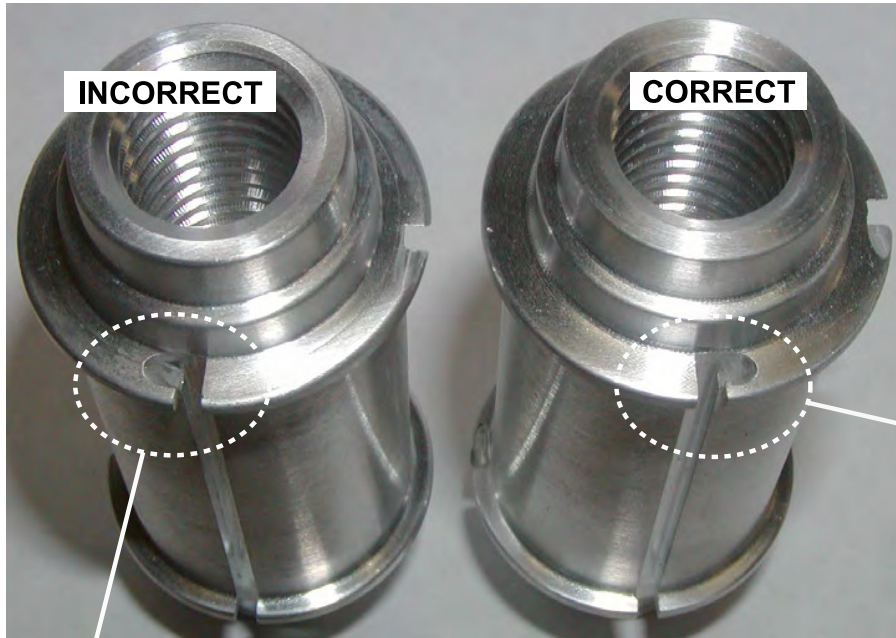
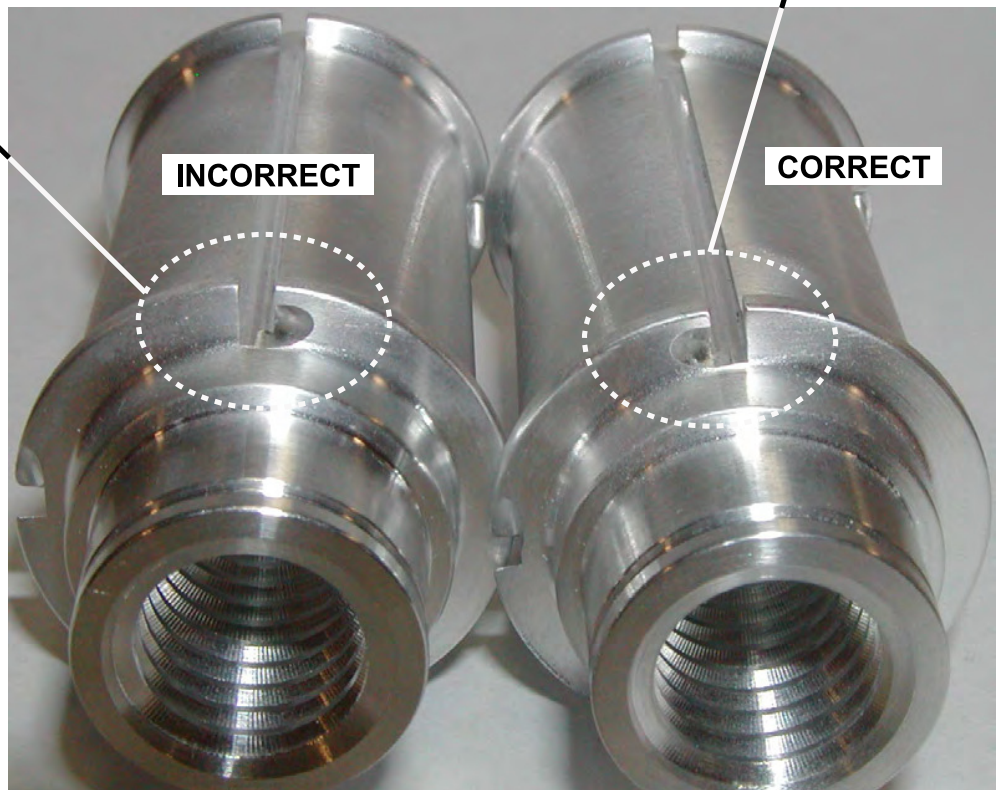
Figure 2

NOTE: A correct trim barrel is distinguished by visual examination of the stabilator trim cable at the locations where the cable passes through the slots in the upper and lower flanges of the trim barrel. A correct trim barrel will feature diagonally machined grooves in the flange to accommodate the cable routing. The installed cable is nested into these grooves, reducing cable strain. An incorrect trim barrel will have these diagonally machined grooves located on the opposite side of the slot from the cable routing.

INCORRECT geometry of diagonally machined grooves in the stabilator trim barrel flanges.

- If the geometry of the stabilator trim barrel matches the illustrations marked "CORRECT" in Figure 2, then the stabilator trim barrel is acceptable for continued use. Reinstall the tailcone access panel, and proceed to Part IV.
- If the geometry of the stabilator trim barrel matches the illustration marked "INCORRECT" in Figure 2, replacement of the stabilator trim barrel and aft stabilator trim cable is required. Proceed to Part III.
